Manhole Inspection Summary

Manhole # S23E1_010MH

Insp Date: **11/20/08 10:33 AM**

Location Address: **2621 Waterview Ave.**

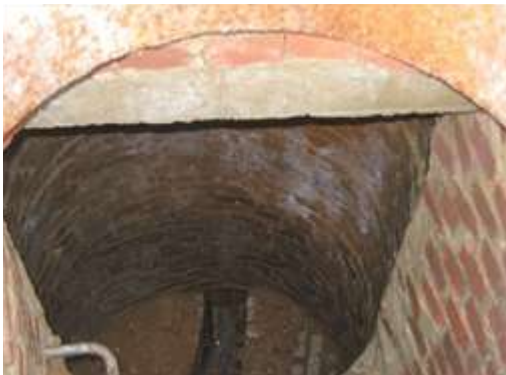
view of manhole

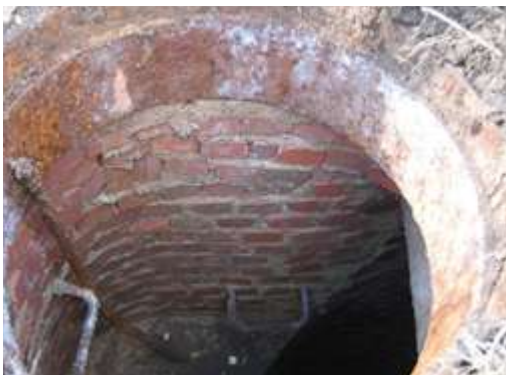
Defect 1

missing mortar at the corbel

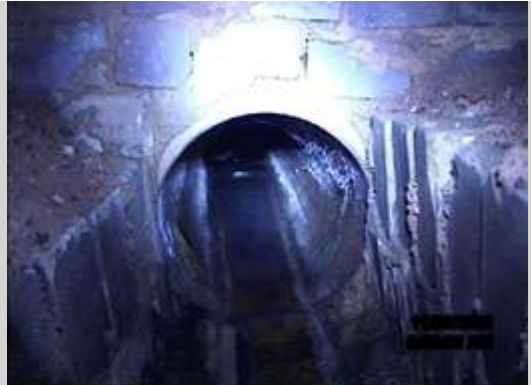
12 O'Clock Outflow

0 in. Circular Gravity Sewer
Pipe out @ 12 O'Clock

Infiltration: **None** Pipe Seal Cond: **Sound**

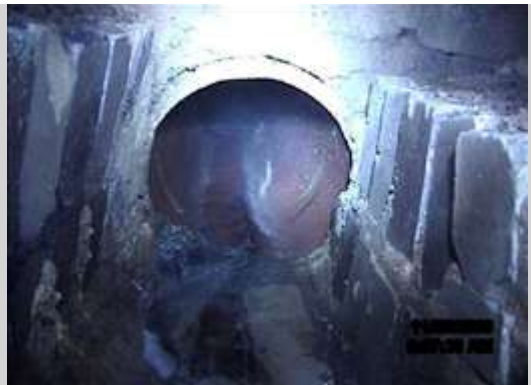
3 O'Clock Inflow

0 in. Circular Gravity Sewer
Pipe In @ 3 O'Clock

Infiltration: **None** Pipe Seal Cond: **Sound**
